The Sarcophagi Garden in Ephesus.

Condition survey of 21 sarcophagi and conservation of the
“Amazon Battle” sarcophagus

Barbara Rankl

The following paper summarises a diploma thesis at the Institute for Conservation, University of applied Arts Vienna, finalised in 2016 and featuring the investigation and conservation of sarcophagi in

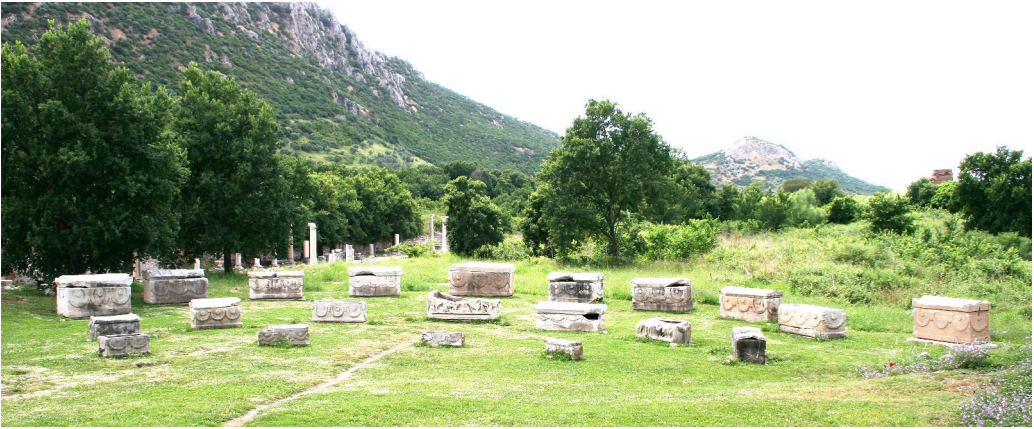
Fig. 1: Sarcophagi Garden in Ephesus, overall view. – Sarkophaggarten in Ephesos, Gesamtansicht.

The presentation of 21 stone coffins is located in an area of the archeological park Ephesus (*Fig. 1*). This recent grouping was assembled in the last 10 years. The exhibition is open to the public and is located north of the famous Harbor Street. It can be noted that this collection is no ensemble: the fact that all objects are sarcophagi and come from Ephesus is their only link. In addition, there is no connection between the sarcophagi and the site or its surroundings.

The two significant causes of damage occurring in the Sarcophagi Garden have been discussed in the condition analysis and are on the one hand climate-based, and on the other hand anthropogenic. In order to protect the objects from future damage an optimal solution would be the building of a roof construction and a barrier. Another recommendation is to dismantle the objects and to create a better placement.

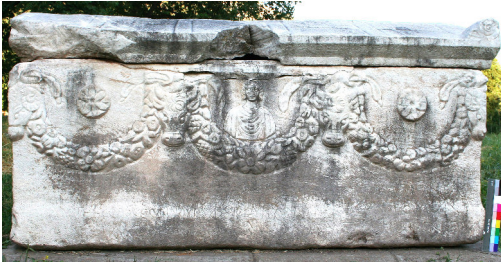
This complex is comprised of several sarcophagi types. Proposals for a possible classification in groups of objects can be as follows: 7 of the 21 objects belong to the group of garland sarcophagi (*Fig. 2*), a type decorated with garlands, which is a typical design in Asia Minor (KOCH, SICH-

Fig. 2: Garland sarcophagus, Sarcophagi Garden. – Girlandensarkophag, Sarkophaggarten.

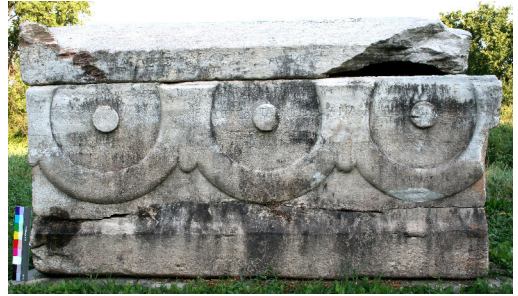
TERMANN 1982, 499-500). The largest group are the 11 unfinished garland sarcophagi (Fig. 3). These products are in a quarry state and illustrate an intermediate stage in the manufacture of a completed sarcophagus (KOCH, SICHTERMANN 1982, 499-500). The decorations were left in an embossed state, meaning they were left standing proud but only roughed out. Apart from the main groups now featured, there is also a frieze sarcophagus, known as the “Amazon Battle” sarcophagus, which is described in more detail later. Other exceptions include a sarcophagus, which has both figural representations and garlands, and a coffin which was left plain and undecorated.

Fig 3: Unfinished garland sarcophagus, Sarcophagi Garden. – Girlanden-Halbfabrikat, Sarkophaggarten.

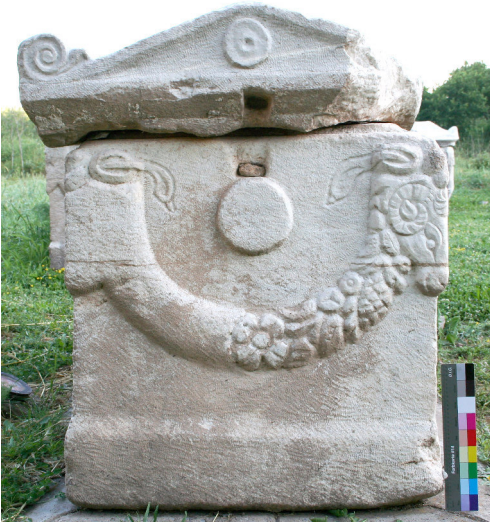
Fig. 4: Secondary side of a garland sarcophagus, decorations are partially unfinished. – Nebenseite eines Girlandensarkophags, zur Hälfte ausgearbeitete Girlande.

It is particularly interesting to observe that some sarcophagi illustrate different stages of completion in their decorations. Coffins have often been placed inside tombs or mausoleums and stood in niches or on a wall. Hence it was not necessary to fully finish all the sides. Figure 4 shows such secondary sides.

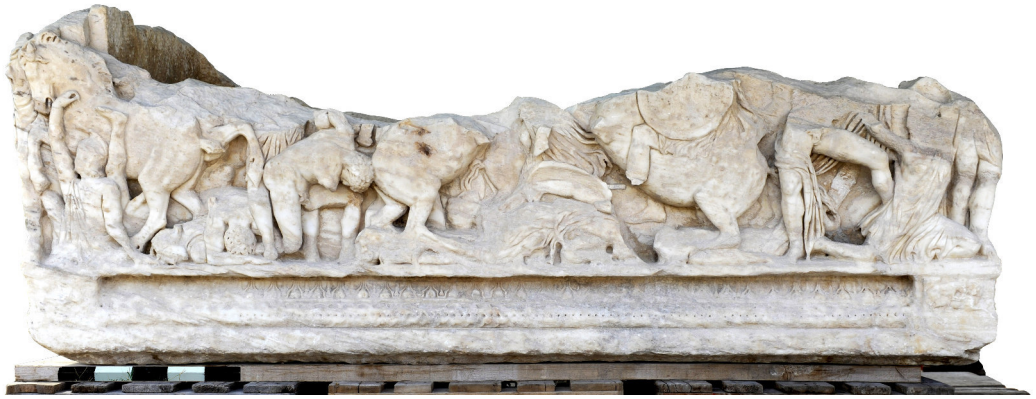
This fragmented corpus has ornaments in the base area and a figural frieze on all four sides (Fig. 5). The relief shows scenes of fighting between Amazons and Greeks. The sarcophagus was made around 190 AD, is of Greek origin and its production can clearly be assigned to Attic workshops (RUDOLF 1989, 33-38). This means that the object is an imported marble sarcophagus and very rare among the collection of sarcophagi on site. The coffin was brought immediately after its excavation in the 1930s to the Ephesus Museum

Fig. 5: “Amazon Battle” sarcophagus, front side, condition after treatment. – Amazonenschlachtensarkophag, Vorderseite, nach Restaurierung.

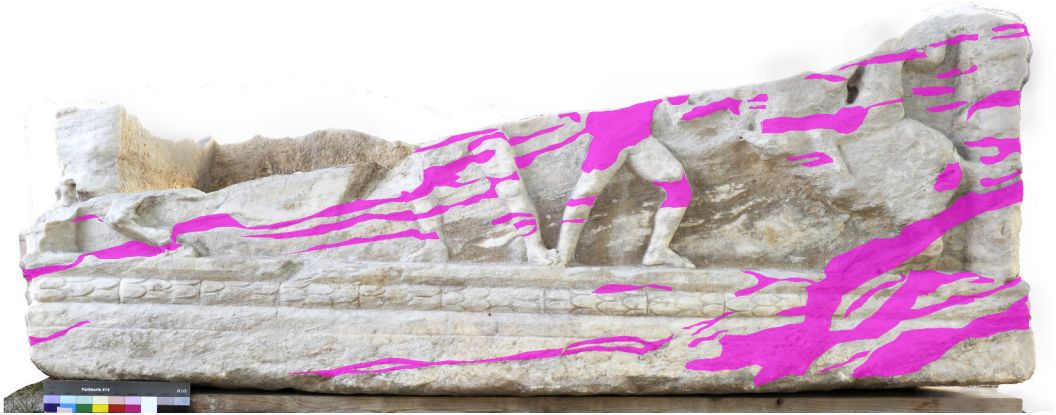
The structural characteristics of the samples taken are consistent with the general characteristics of Pentelic marble (Fig. 6). On the back-side of the object, layers were found, which could be identified as mica, more precisely as Muscovite and Serizite (Fig. 7). Inclusions of other minerals were also detected.

Fig. 7: Inventory mapping, back side, mica layers (purple). – Bestandskartierung, Rückseite, Glimmerlagen (lila).

homogeneous and does not correspond to the usual quality of Pentelic marble, especially at the rear.

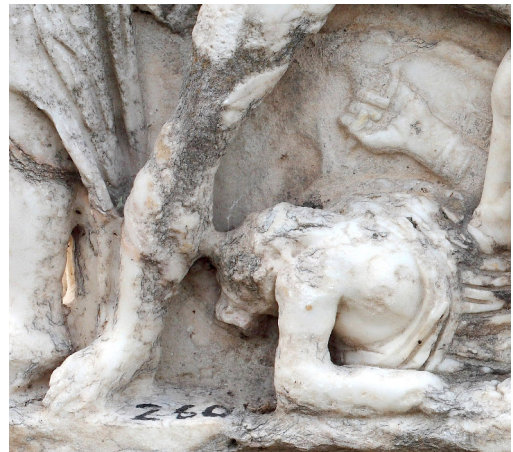
The detection of all types of damage, the evaluation of microscopic and microbiological investigations, as well as the in situ measurements, such as ultrasound measurements are documented in the condition analysis of this object (Fig. 8): The stone coffin is in a poor condition, as distinct types of damage are noted and these are coupled with acute loss of substance. The matter is urgent and immediate conservation measures are needed to reduce and stop the loss of surface.

Fig. 8: Condition before conservation, detail of right side of sarcophagus, damages visible are delamination, scaling, sugaring and biological colonization. – Zustand vor Restaurierung, Detail von rechter Seite des Sarkophags, Schadensbilder sichtbar: Schichtspaltung, Schalenbildung, Zuckerkorrosion, biogene Besiedelung.

The object had to be removed for the conservation procedures and transported to a workshop. After cleaning and the removal of various deposits, the biocide treatment could be carried out. It was necessary to find differentiated approaches for the interior and the exterior. The lichens could be partially removed with potassium hypochlorite, a new agent in its use for conservation.

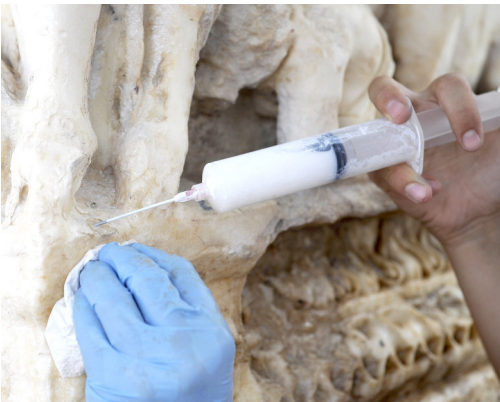
Fig. 10: Consolidation with nanolime. – Festigung mit Nanokalk.

in the calcite structure. For a successful consolidation, those areas had to be treated differently. For the calcite structure, nanolime was used. This is a consolidation medium which is highly compatible with carbonate substrates (*Fig. 10*). For the mica layers a different consolidate was used: a stone strengthener based on silicic ester, which is highly compatible with silicate substrates.

Using micro-pointing procedures, the three types of damage – scaling, sugaring and delamination – were stabilized and closed as part of the same action.
